## Troubleshooting Transducer Noise

Drawing Title: SD and 2XD Common Mode Caps	Part Number: SDOC023	Revision: 000	Drawn by: NJC	Sheet 1 of 4	Date: 8/13/2020
---	-------------------------	------------------	------------------	-----------------	--------------------

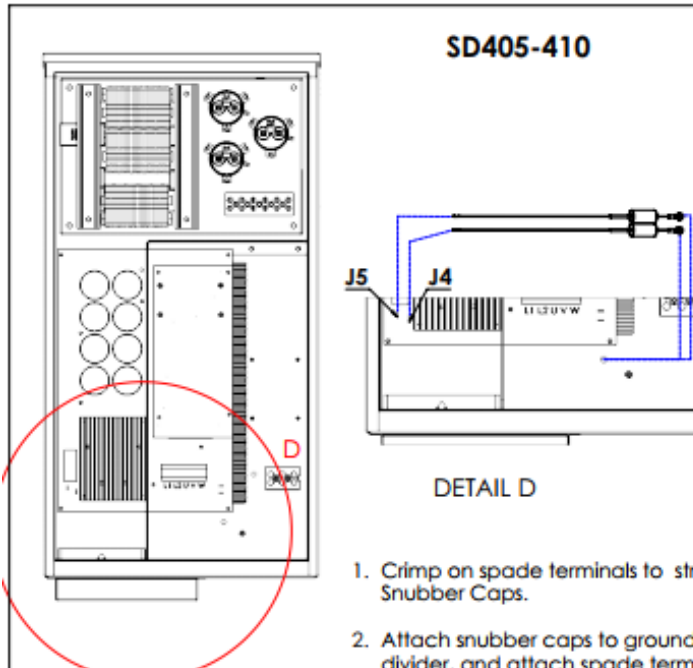
**DETAIL D**

### SD405-410

1. Crimp on spade terminals to stripped wire end of both Snubber Caps.
2. Attach snubber caps to ground lug. Route wires under divider, and attach spade terminals to J4 and J5. Do not impede access to Ground Lug.

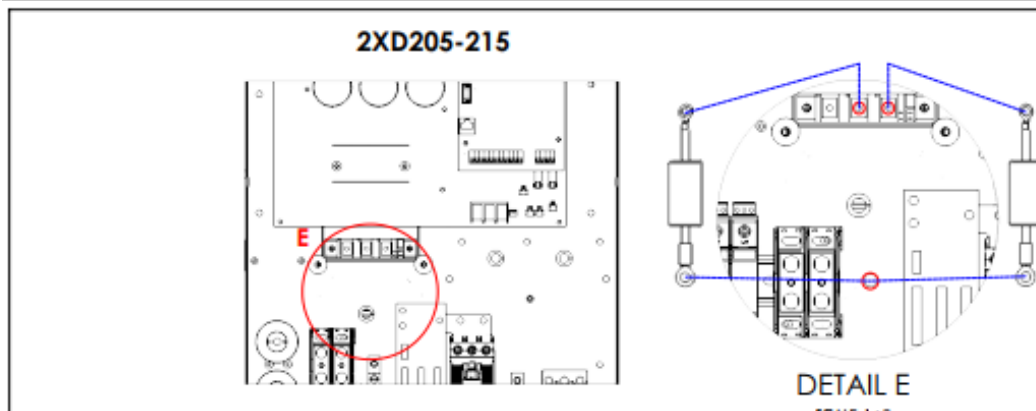
**DETAIL E**  
SCALE 1 : 2

### 2XD205-215

1. Cut stripped wire down to length needed and crimp ring terminals on to stripped wire end of both snubber caps.
2. Route Snubber Cap wires from the input diode middle and right terminals to ground lug. (see photo)
3. Do not impede access to Ground Lugs
